Error search on the PAF BE, especially at Beamformer BF#06:

Max-Planck-Institut
für Radioastronomie

Effelsberg, den 13.05.2020

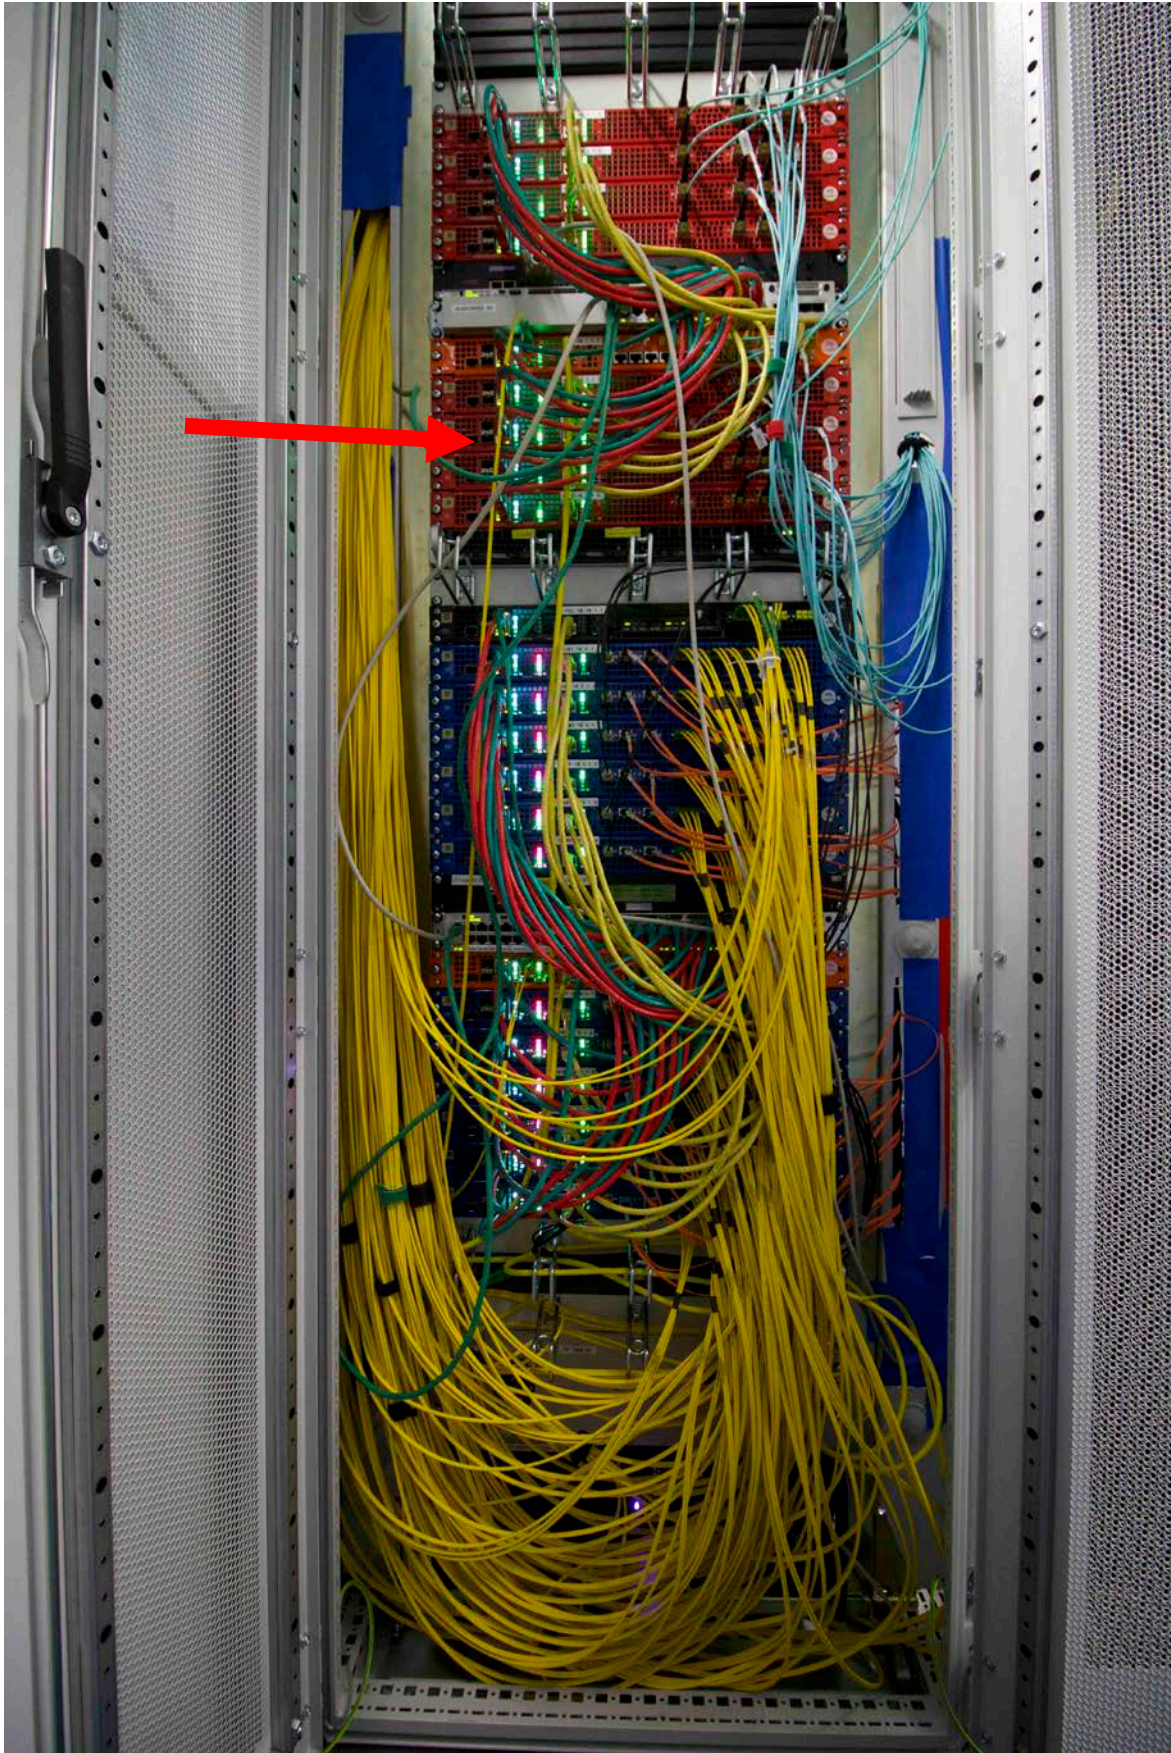
LED status on BF#06 is as follows:

X: Aqua
T: off
M: off
P: off

Error messages on tossix are:

- Busy | loading firmware
- Low Power | Startup error: configuration error
alternatively, after powering up:
- Low Power | Startup error: link error

Card	PDU			IOC			
	Status	Control	Comms	Control	State	Startup Progress	Startup Status
c01	Disconnected		Connected	Startup	Shutdown	IDLE	startup done
c02	Disconnected		Connected	Startup	Shutdown	IDLE	startup done
c03	Disconnected		Connected	Startup	Shutdown	IDLE	startup done
c04	Disconnected		Connected	Startup	Shutdown	IDLE	startup done
c05	Disconnected		Connected	Startup	Shutdown	IDLE	startup done
c06	Disconnected		Connected	Startup	Shutdown	Low Power	startup error: link error
c07	Disconnected		Connected	Startup	Shutdown	IDLE	startup done
c08	Disconnected		Connected	Startup	Shutdown	IDLE	startup done

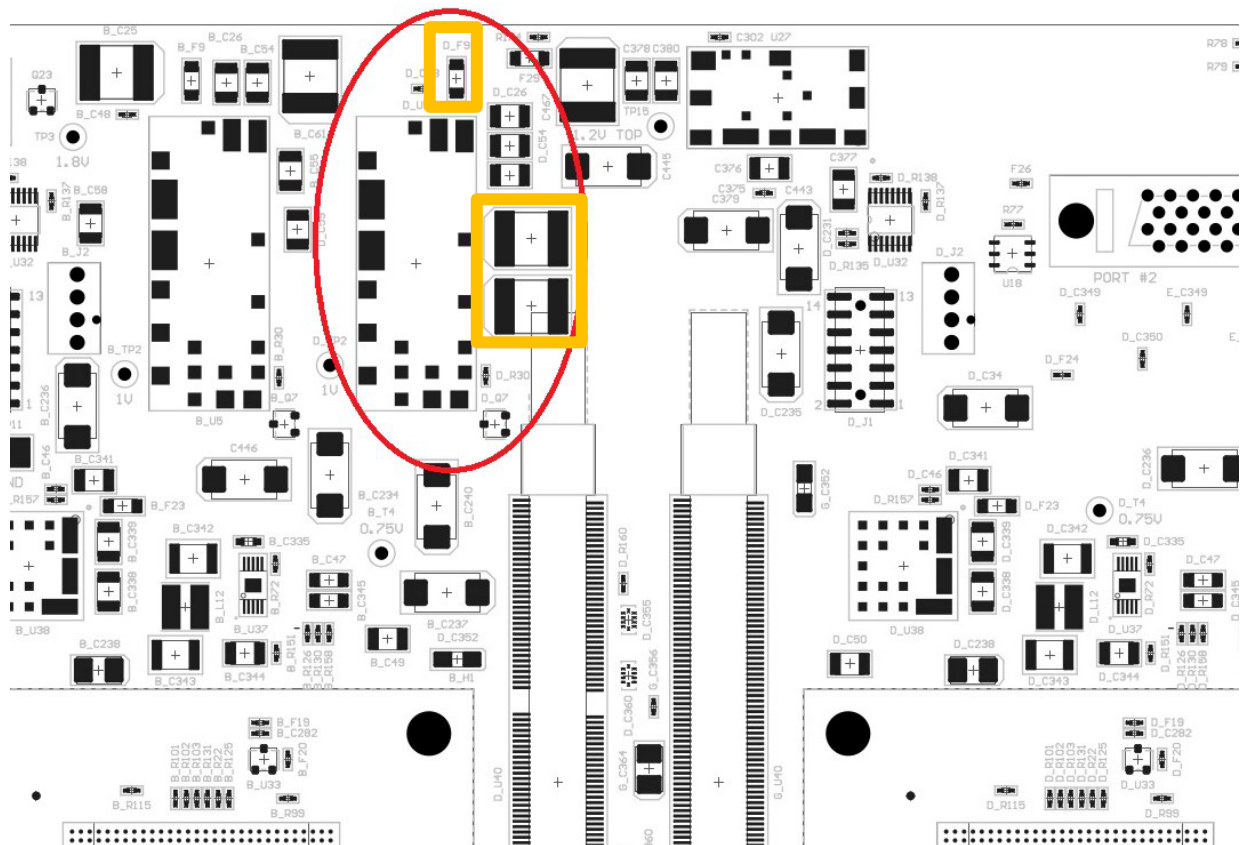
As a solution for this problem Daniel George CSIRO suggested to investigate the components around one of the 1V power supplies on the board:

You should not use just any ATX supply that fits as we use the comms bus to monitor and control the supply - some have issues and require firmware changes to make them work. I think the ATX supply is OK and the issue is with one of the 1V FPGA power supplies on the DSP board. The electronics group should do a physical inspection of the Redback board, looking around this supply to see if one of the capacitors is shorted or the ferrite bead on the 12V input has blown. Pay particular attention to the components D_F9, D_C61, D_C25, D_C26 (see attached for location). These components are all on the top so the board doesn't need to be removed for this inspection.

After replacement of the elcos D_C25 and D_C61 with 100uF/35V each and D_F9 with a wire bridge the board came up with normal function. The capacitors are Vishay Sprague 594D107X0025R2T, the ATX power supply is Computec CPS-4411-1A1.

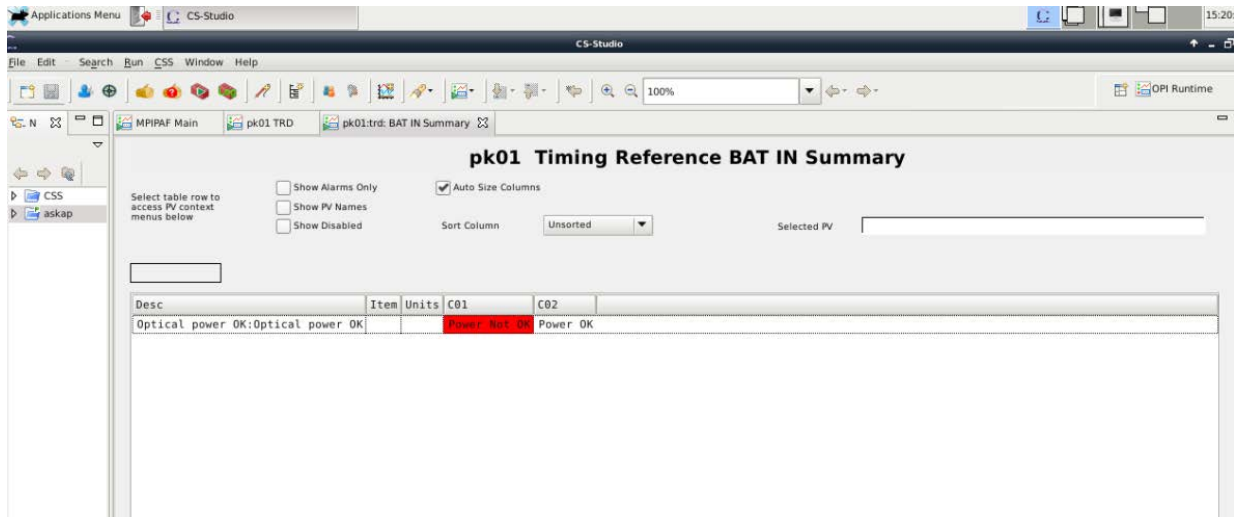
After fixing this there was another error on the TRD unit indicating low optical power on the optical input of the BAT signal. This turned out not to be connected so the error has been taken out of the error management and is ignored by the system now.

I am not however able to "Reset & Enable links" and also "sync reset".

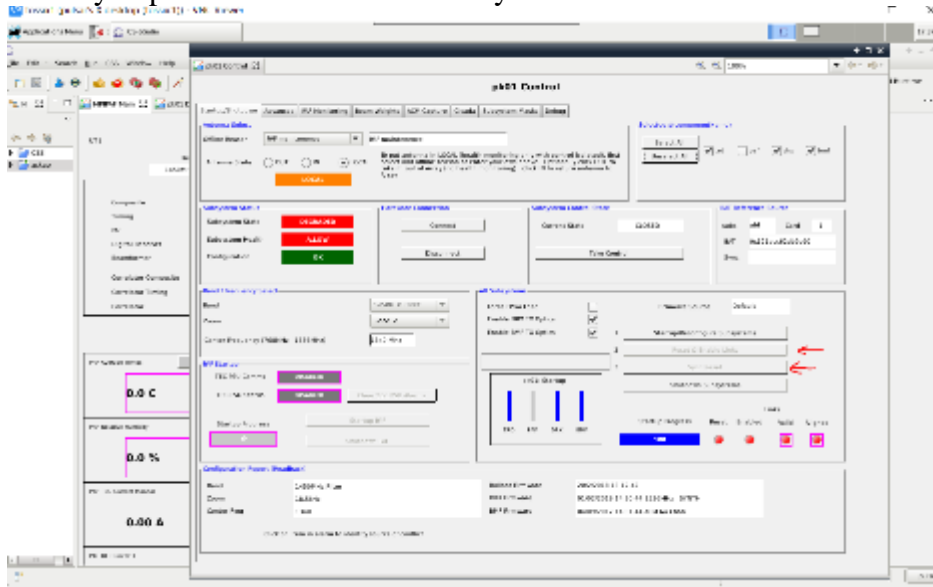
The optical BAT signal is not used on your system (a yellow copper CAT5/6 is used instead).

There was enough power before to prevent that alarm but it can be ignored (I can probably disable it). One of the two fibres to the timing cards is still needed for the clock reference.
