**[ADESCOM-272] wiped bias current config memory in MPIFR PAF** Created: 05/May/17 Updated: 11/May/17

The bias current config memory is wiped on all four backplanes on the MPIFR PAF. This appears to be preventing successful PAF startup at Bonn.

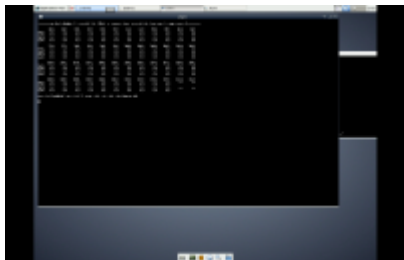
This screenshot shows that the PAF bias current config memory has been wiped on all backplanes

This manifests in startup errors:

For now we follow the workaround in [ADESCOM-27](#) of unchecking the optical startup enable. This results in bias currents that are falling off the low end of the acceptable range. This is good enough

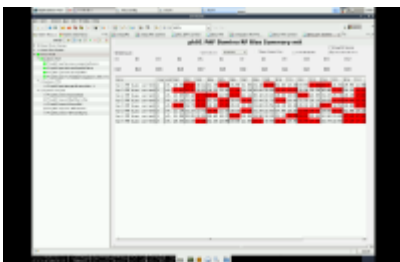
Domino RF Bias currents before fixing the bias settings:

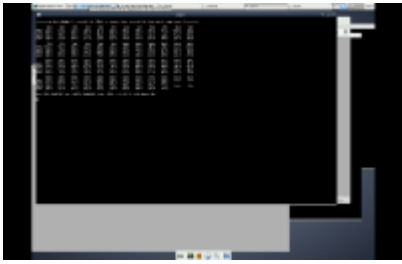
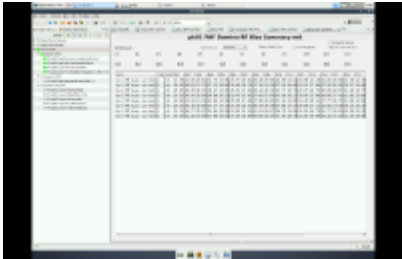
Following that we get sensible readback of the bias settings and reasonable bias currents as show

I just uploaded the settings [Cheng, Wan \(CASS, Marsfield\)](#) provided via this file [serial\\_numbers\\_up](#) Reload option in the *Test PAF Power-up* sub-menu of `pa f . py`.

The Domino bias settings have been reloaded, but we should double check that they are persistent.

The PAF was just power cycled and the domino bias settings were persistent.
