CRYOGENIC PHASED ARRAY FEED

EFFELSBURG PAF EVALUATION JUNE 2018

Evaluation and commissioning of the warm PAF system at the Effelberg 100m telescope in June 2018

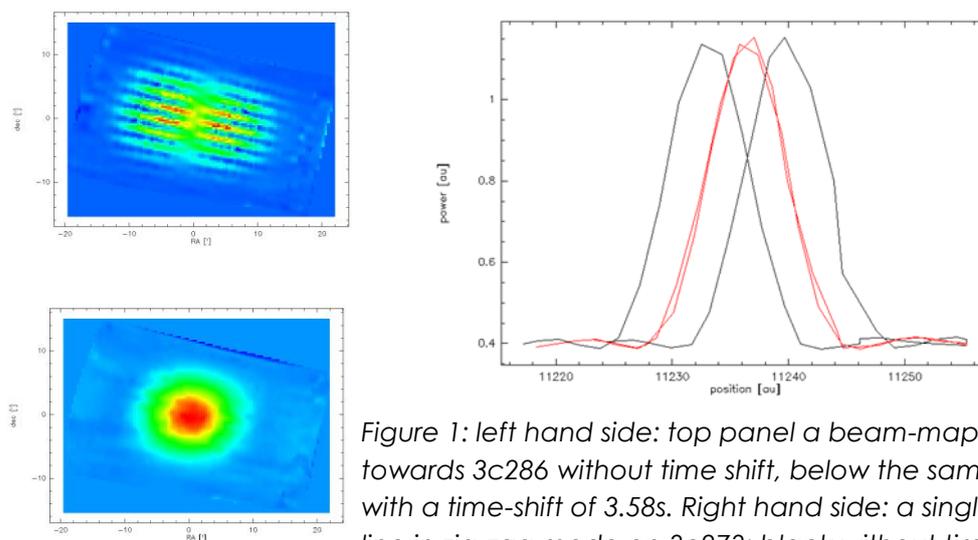
We detected a time difference of the order of 3.5 seconds between the position data in the meta-data stream, and the voltage value stream (both created / modified within the beam-former). So far it is unclear where the offset is introduced.

Figure 1: left hand side: top panel a beam-map towards 3c286 without time shift, below the same data with a time-shift of 3.58s. Right hand side: a single scan line in zig-zag mode on 3c273; black without time-shift, red with time shift of 3.11 s.

The telescope is synchronized to the IRIG-B signal and this signal is also directed to the PAF system. Since none of the other receivers has such a problem it is very likely that it is PAF system related.

- The internal timing supply is not synchronized to the telescope,
 - e.g. IRIG-B is not connected or not used.
 - ➔ Any time-delay is possible
- The flux calculation pipeline introduces a time-offset.
 - ➔ Time delay usually should be in the order of half of the integration time (here 0.9s).

This effect is present and seems to reduce the overall shift by half of the integration time. The calculation will be corrected for the next run.

- The beam-former internal algorithm calculating the meta-data time-stamps is inaccurate / insufficient.
→ Effect is unclear

We need to check the PAF timing system and its synchronization with the telescope prior to the next observing run. In addition we have to get an understanding how time-stamps are processed by the beam-former system. As last action we have to verify that the flux calculation pipeline deals correctly with the time-stamps of the beam-former voltage stream.

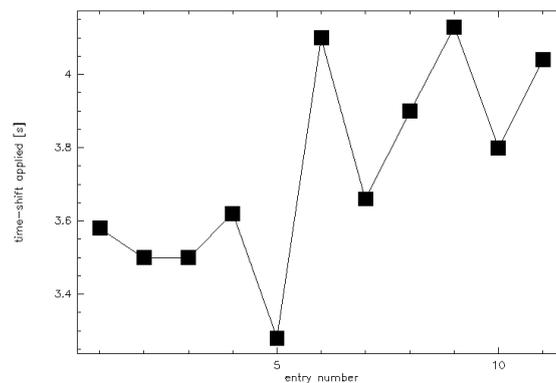
Figure 2: Jitter of the applied time-shift over the observing run. First data taken are plotted on the left and last map on the right.

It seems that the jitter was increasing over time. But since the uncertainty of the shift determination is quite large this may results from the data reduction process itself.

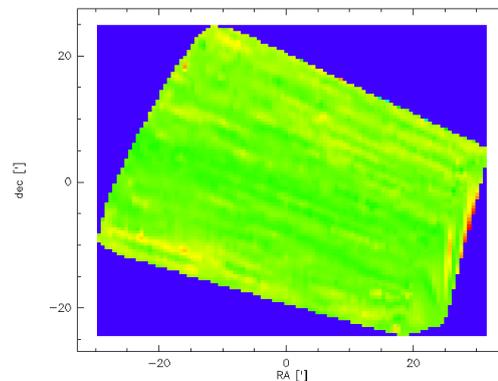
For the upload of the beam-former weights two different GUIs are applicable, but only one of them is (partly?) working. Hence we have seen crazy beam-shapes, unexpected system behavior, and unreliable operations in general.

Figure 3: Not an unusual beam-map. Because of unnoticed software failures / operation-mistakes the data recorded is unusable. In this case 3c286 is invisible because beam-former weights were not uploaded correctly.

The uploading of the beam-former weights needs a description in the manual. Important here:

- which GUI has to be used,
- do NOT press the “apply beamweights” button since it kills the data streaming connections,
- where to find the log-file (see below)

The log file shows the filename of the last loaded beam-former weights file. It would be good to automatically display this filename and hence give a feedback for the operator. At least the log file needs to be checked after uploading new beam-former weights. A manual describing these tasks will be provided in future.

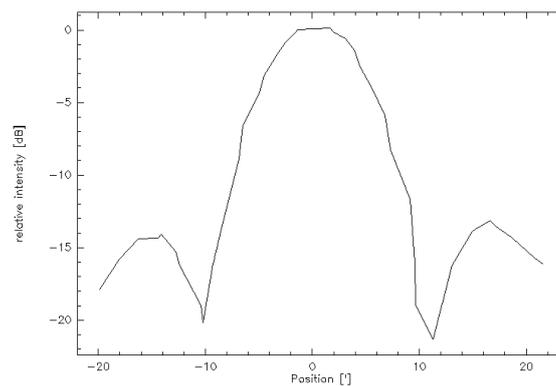
The beam looks clean and has in the maps a low side lobe level. As mentioned above the large map to make the side lobe visible was incomplete and not usable. The only side lobe impression we got from a cross scan on 3c273. But the side lobe level seems to be higher than the visible side lobe of the maps.

Figure 4: First side-lobes of the main beam are more than 10 dB below the main beam maximum power. Scan was taken on 3c273.

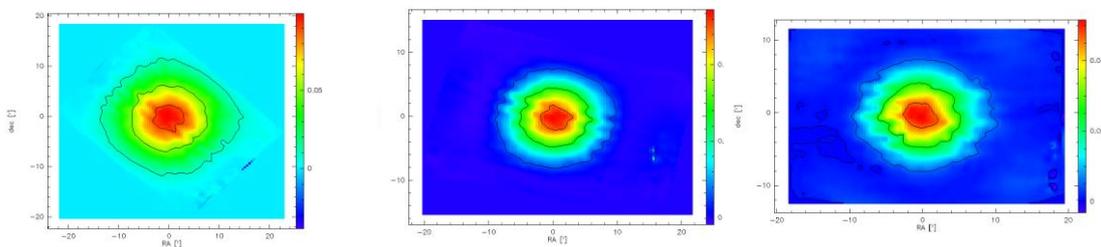
Figure 5: Beam-maps of all three frequency bands (lowest frequency at left hand side). Contours, as far as available are on 90%, 50% 10% and 1% level. A side lobe above 2% as indicated from the cross scan above should be visible in all maps.

The beam is as far as we can tell with the timing uncertainties round and clean. A larger map with better signal to noise is required to trace down the first side lobe correctly.

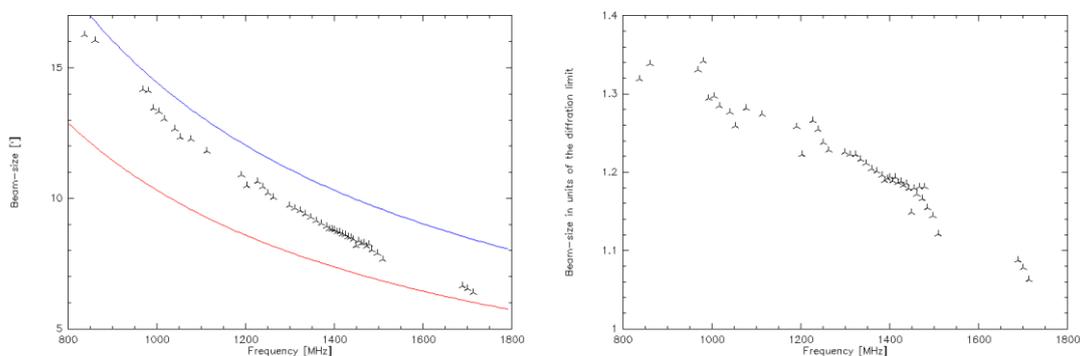
The beam-size of the formed beam changes relative to the diffraction limit with frequency (all measurements taken on 3c286). At the low frequency end it is nearly 1.4 times the diffraction limit, and hence we do not use the full dish here. At the high frequency end it is about 1.1 times the limit. A well matched horn antenna based receiver usually has a beam about 1.1 to 1.2 times larger than the diffraction limit.

Figure 6: Fitted beam-size (black triangles) versus frequency. The red curve denotes the diffraction limit of a 100m dish and the blue curve is at 1.4 time of this value. The right hand side figure shows the beam-sizes in units of the diffraction limited beam. We fitted the beam-maps using 12 MHz wide frequency chunks for all three frequency bands of the PAF. But the high and the low band had a lot of RFI within. Therefore the data-quality especially towards the lower and the higher end of the plot is limited. In the area around 1400 MHz the mid and high band overlap. Both data sets are in good agreement here.

The reason for this behavior is unclear to us. It could result from the interplay between maximum signal to noise beam-former and the frequency dependent illumination function of the individual antenna. Also RFI could play a role here.

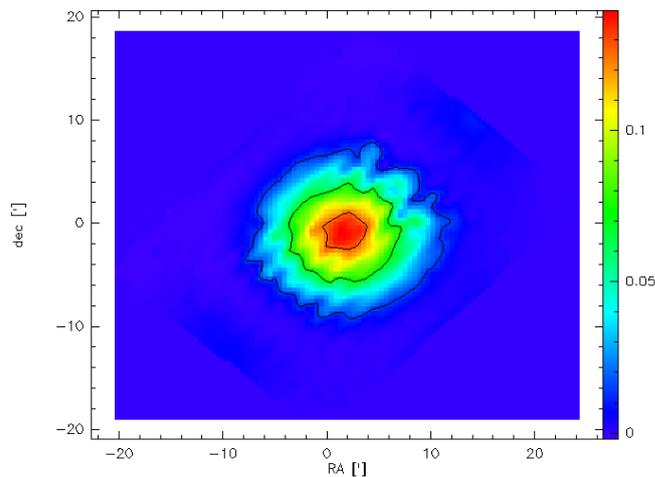
In the last map we took during this run (on June 30th) we detected a pointing offset. So far we never checked the position, but here it was done. The pointing was off by about 2', more than 20% of the FWHM beam-size.

Figure 7: Map of 3C286 in the late morning directly after it came up. The offset of 1.7' in RA and -1' in dec is visible by eye already.

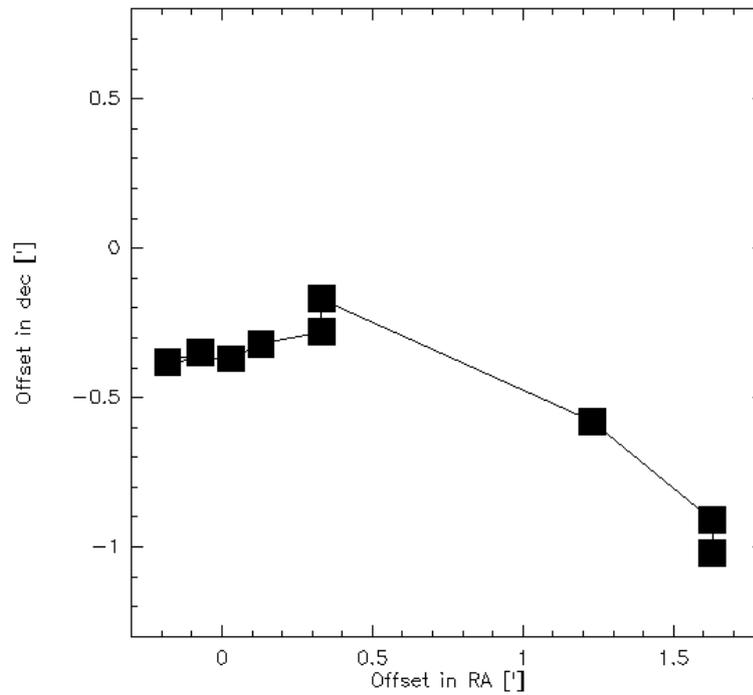
After we detected the offset we looked at all other offsets in the data. They have been fitted together with beam-sizes and signal strength for the focus measurements. One can see a clear trend of the pointing offset with the time of the day. This means the offset changes with the sky rotation and therefore this denotes that the main beam is formed of center of the telescope focal plane.

- beam-former uses wrong epoch for its calculations;
- signal to noise beam-former weight determination algorithm is influenced by RFI;
- pointing constants used for the PAF within the telescope system are wrong;
- using the scanning modes introduce an position error (scanning pattern rotates with the source)
-

For all of the above points it is unclear if they can explain the effect. Nevertheless a pointing offset of up to 2' will influence the astronomical data and must be taken out.

Figure 8: Offsets in the position of 3c286. The positions are connected in the order of the time of the day, starting at the right hand side with large RA-offsets around 13:30 and stopping at the left end with an RA offset of zero around 20:50.

Especially with the above mentioned pointing inaccuracies of up to 2' one needs to check the pointing on a regular basis on a source close to the observing target (at least as long as the reason for this is unclear).

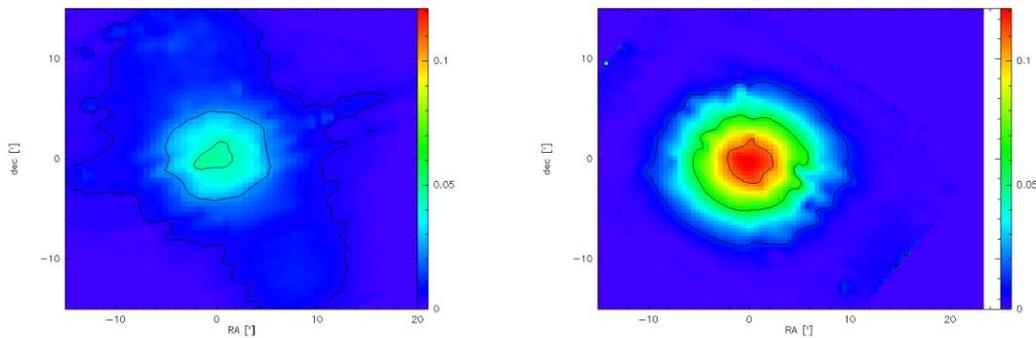
Figure 9: Comparison of the beam without new beam-former weights (left hand side) 164mm out of the nominal focus and with new beam-former weights (right hand side) 200mm off focus. Intensity scale was held fix on both plots; contour levels are at 90%, 50%, and 10% of the maximum intensity.

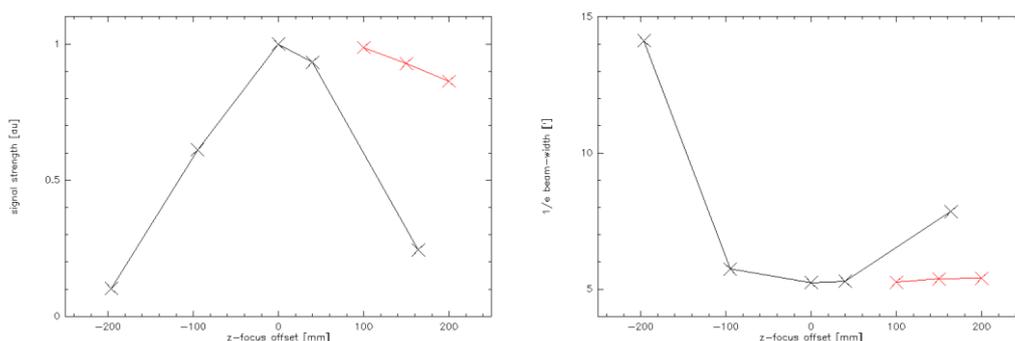
Figure 10: Derived focus curves: Left hand side from averaged signal amplitude and Right hand side from averaged beam-width. Average was taken from frequency channels 180 to 300. The black curve denotes the values without re-measuring and re-calculating beam-former weights after changing Z-focus; the red curves show the values when new beam-former weights were calculated after the focus change.

Our measurements show the expected behavior: without new beam-former weights the focus behaves as any usual receiver (black curves in figure

above). In contrast, the red curves show that the beam-forming measurements are self-focusing over a wide Z-focus range. If this is true also for off-axis beams in the same extend needs to be proven in future.

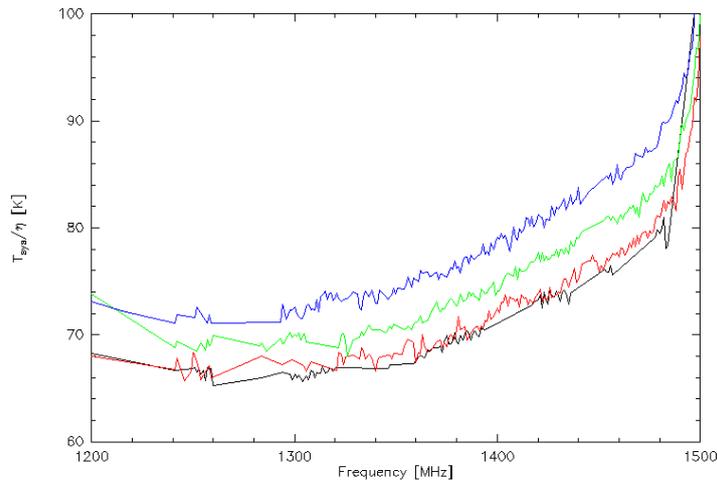
The system temperature for the three of focus curves with re-measured and re-calculated beam-weights increases proportional with roughly 1 over signal strength. Hence the 100mm defocused system has nearly the same system temperature while the one of the 200mm defocused system is increased by about 10%.

Figure 11: T_{sys}/η for the focus offsets at which the beam-former weights have been re-measured: black – in focus, red – 100mm off focus, green – 150mm off focus, and blue – 200mm off focus. RFI was removed by hand from the data.

If beam-former weights are re-measured and updated regularly, taking a focus curve and re-focusing the receiver is not necessary during usual operation. In what intervals beam-weights need to be re-calculated and updated is still (a bit) unclear. The system seems to be stable over days, hence once per day should definitely be sufficient from what we can tell so far.
